62 GREENE STREET

ADDRESS: 62 GREENE ST., NEW YORK, NY 10012
MANHATTAN COMMUNITY BOARD: 2
BLOCK: 485
LOT: 3
ZONING: M1-5A

SoHo-Cast Iron
Historic District
Manhattan
Designated: August 14, 1973

**62 GREENE STREET
EXISTING CONDITIONS**

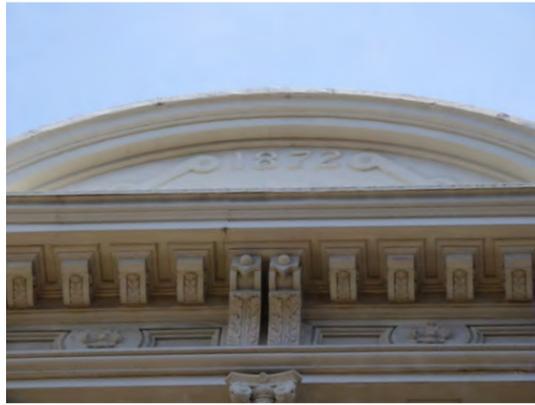
PHOTO 2: Cornice and Pediment. Sheet metal is in good condition.

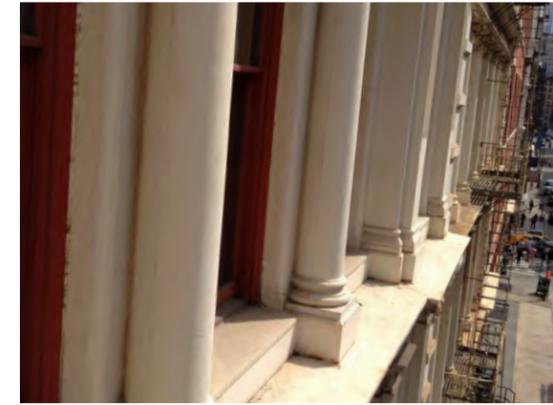
PHOTO 9: Fourth floor water table and columns. Cast iron is in good condition, repainting is required.

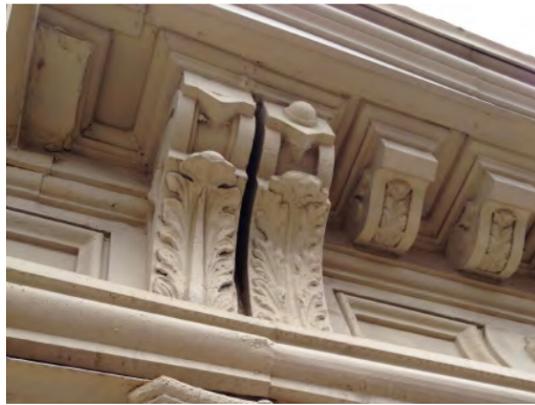
PHOTO 4: Cornice brackets and architrave, cast iron is in good condition.

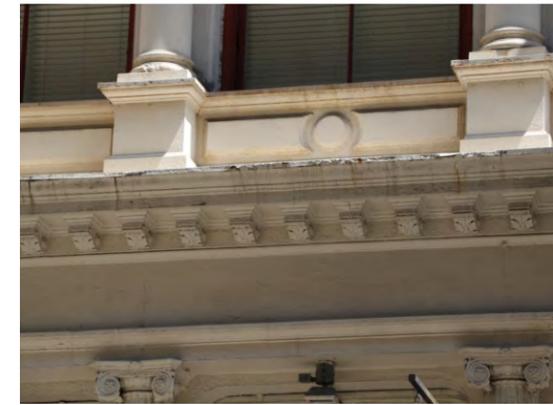
PHOTO 11: Second floor water table and spandrel are generally in good condition. Repairs to the ledge cap plates and repainting are required.

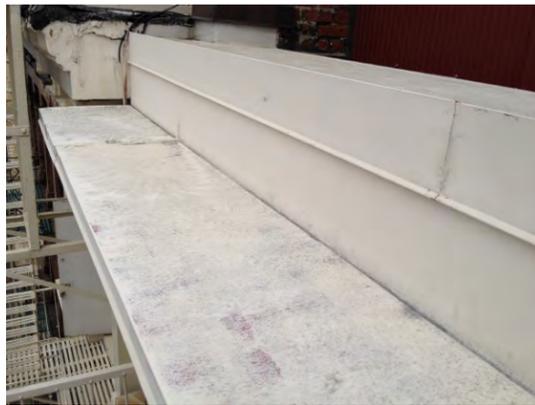
PHOTO 6: Cornice ledge. In good condition, sheet metal needs repainting.

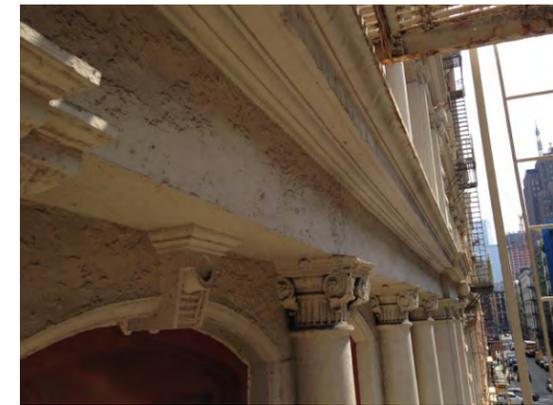
PHOTO 13: Ledge soffits and architraves at fire escape require detailed review. Miscellaneous cast iron fastener repairs required.

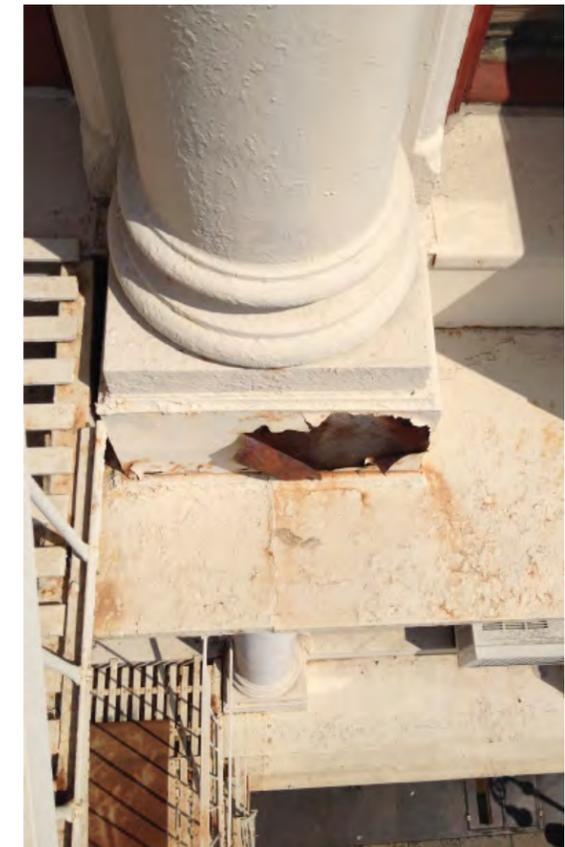
PHOTO 19: Column base. Paint is peeling off. Cast iron is exposed.

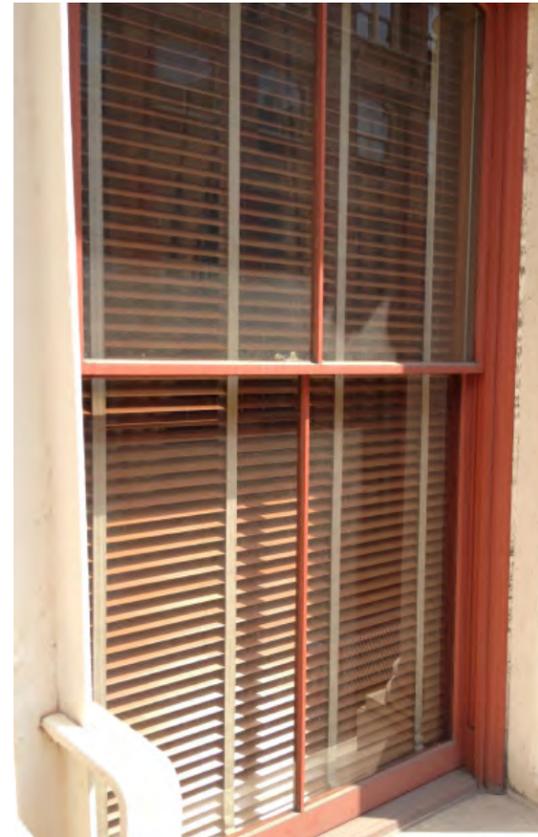
PHOTO 31: 2nd floor. Close up view of double-hung window.

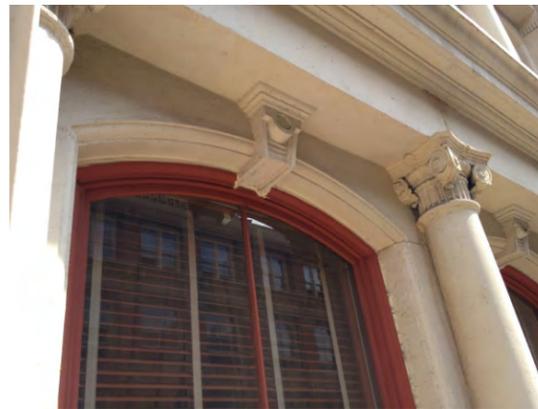
PHOTO 32: 2nd floor. View of top window sash, arched cast iron opening. In good condition.

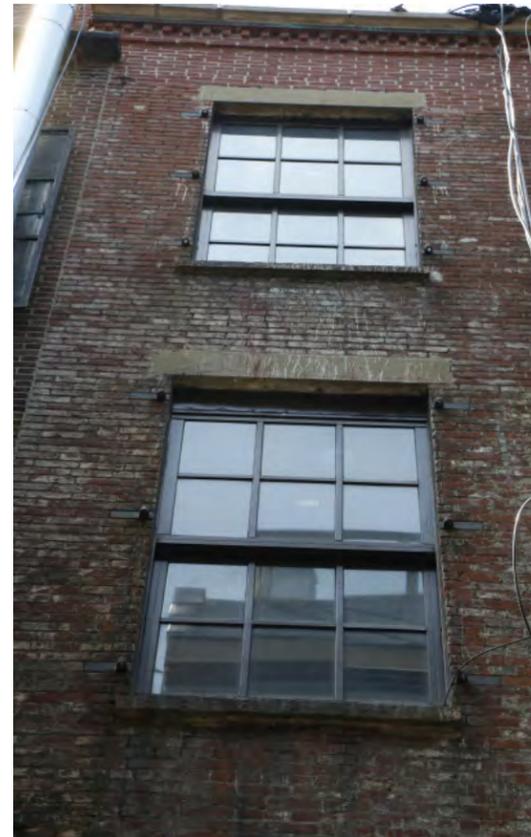
PHOTO 43: Replaced stairwell windows are in good condition (floors 4 & 5).

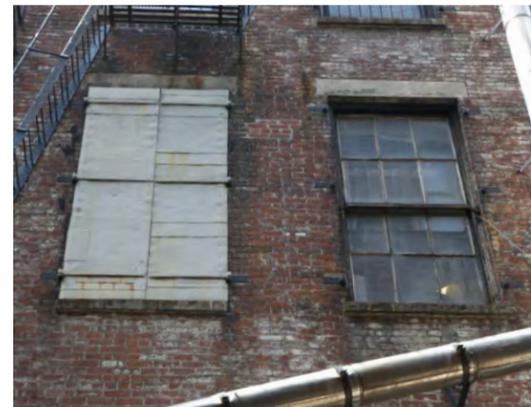
PHOTO 45: 4th fl. windows are old (perhaps original) double-hung wood units w/ single pane glazing. They are in very poor condition.

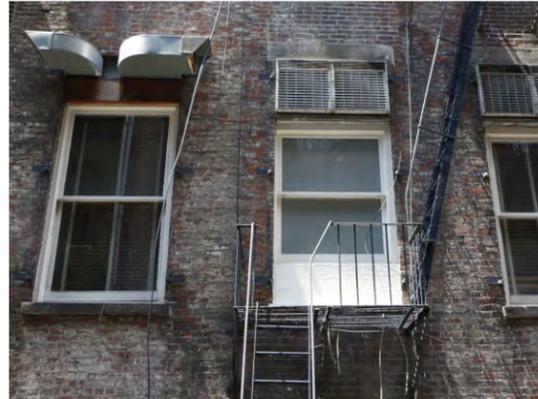
PHOTO 47: 3rd fl. windows, bays 1,2, & 3. Wood windows are smaller than masonry opening. HVAC equip. & ductwork mounted above windows. Entire assembly is in poor condition.

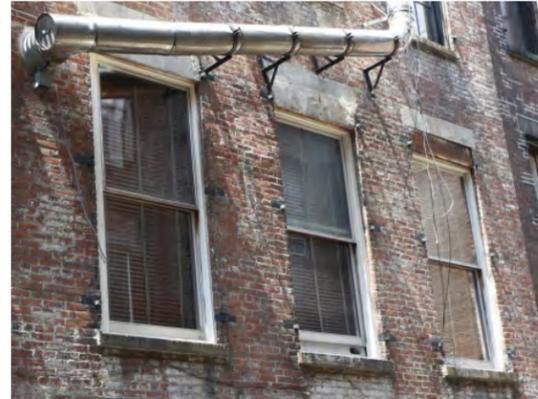
PHOTO 48: 3rd fl. windows, bays 4,5, & 6. Wood window in poor condition.

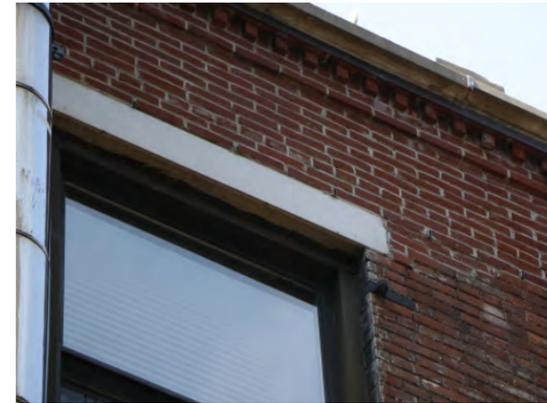
PHOTO 52: Stone lintel previously replaced w/cast stone unit.

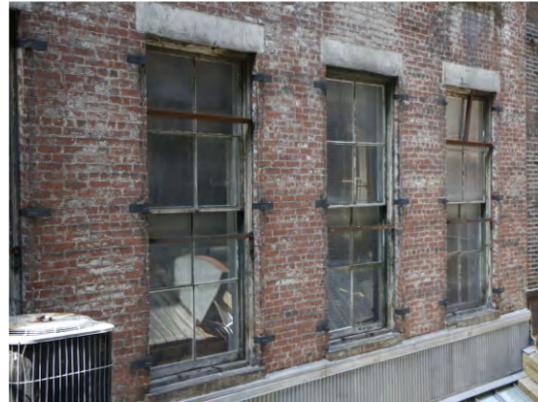
PHOTO 49: 2nd floor windows. Original double-hung wood windows w/single pane glazing are in deteriorated condition.

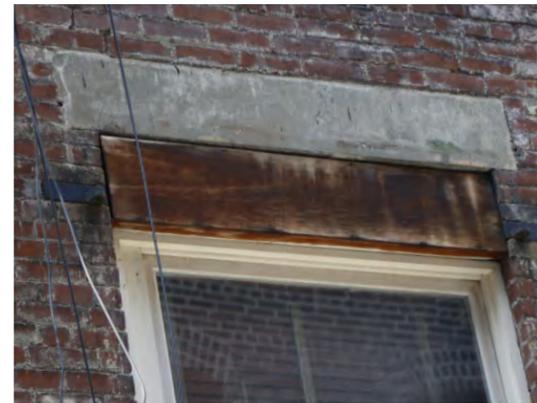
PHOTO 53: Stone lintels on floors 2-4 are in fair condition. Some require replacement. Modified openings require repairs.

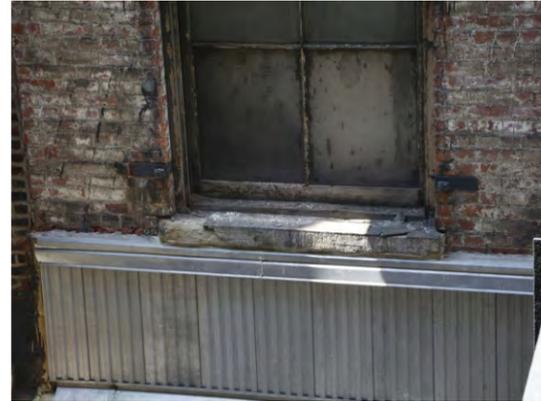
PHOTO 55: Original stone sill, typical condition.

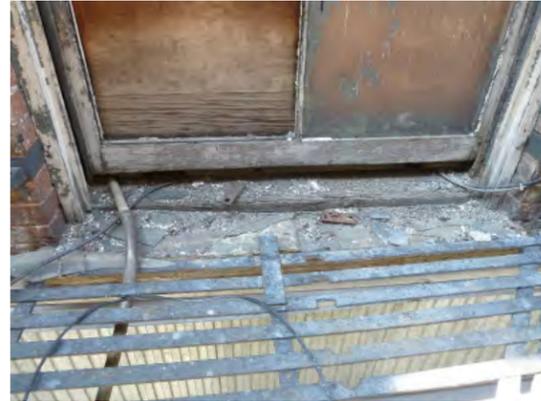
PHOTO 56: Many stone sills are delaminated, and deteriorated beyond repair.

4 STONE WINDOW SILL REPLACEMENT
A-004 SCALE: 3" = 1'-0"

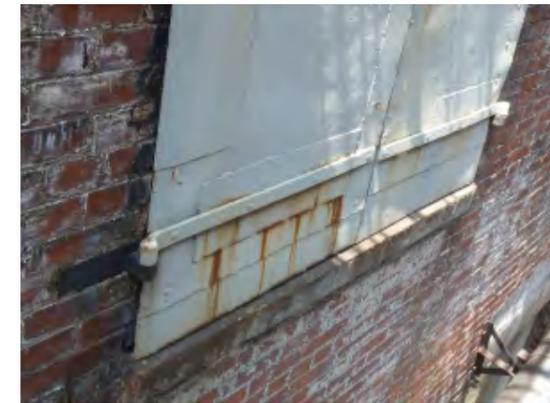
PHOTO 61: Conditions of lower half of shutter.

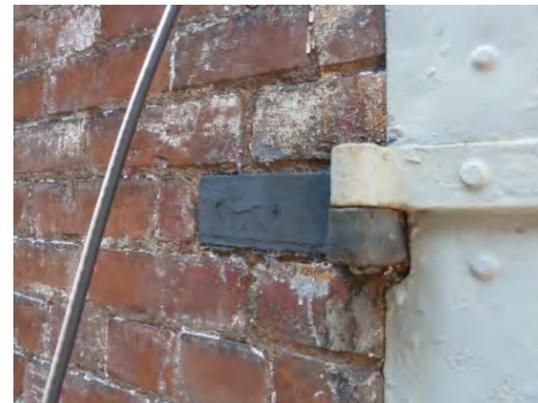
PHOTO 62: Hinge condition at shutter. Rust and corrosion have developed.

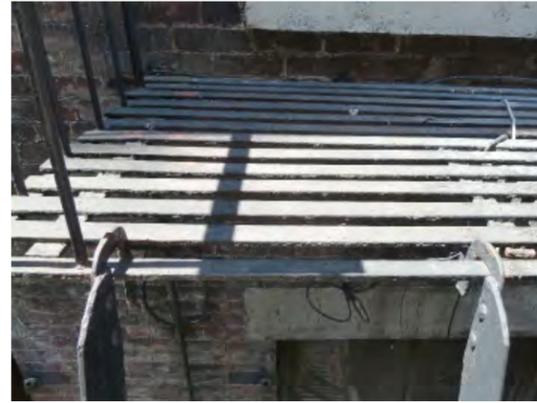
PHOTO 64: Rear fire escape. Ladder hangers at first floor bridge require adjustment.

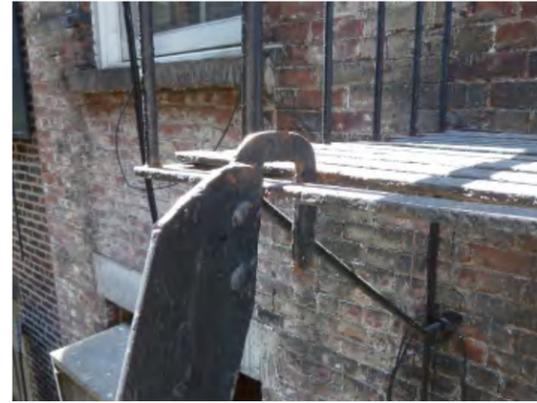
PHOTO 65: Rear fire escape. Close-up view of hanger.

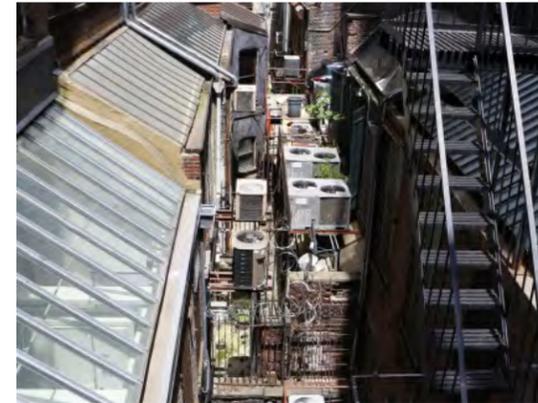
PHOTO 68: First floor level skylight and gutter are in good condition.

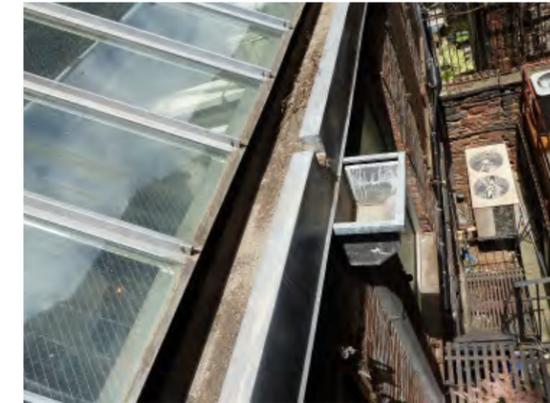
PHOTO 69: Rear skylight and gutter are in good condition.

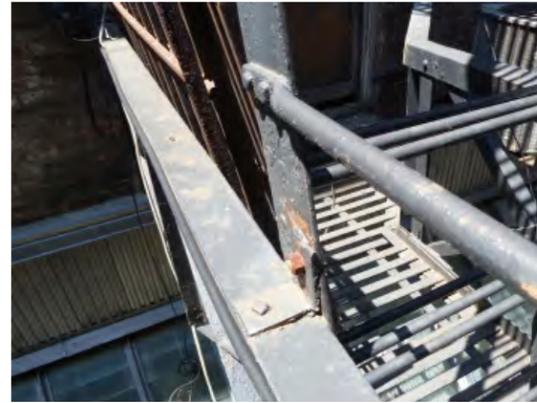
PHOTO 66: Rear fire escape. Review of all connections is required.

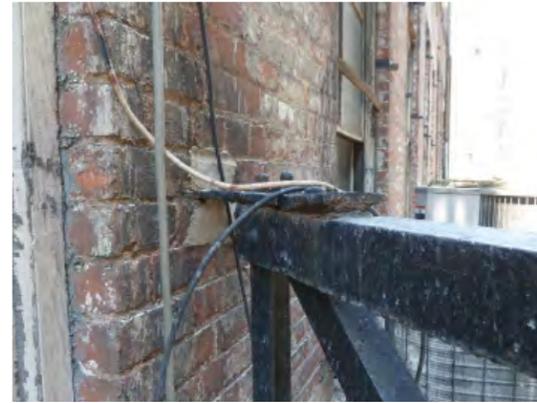
PHOTO 67: Rear fire escape. Masonry penetrations require repairs.

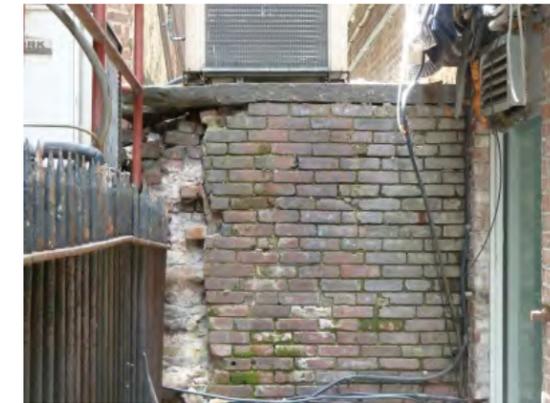
PHOTO 70: East lot line (party) wall at cellar level is disintegrating and requires reconstruction.

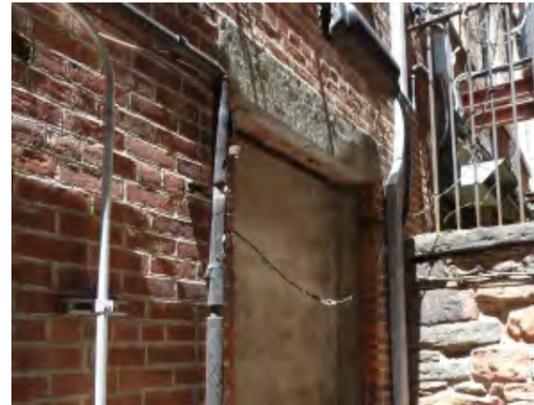
PHOTO 76: Northernmost masonry opening has been infilled. Perimeter is not sealed.

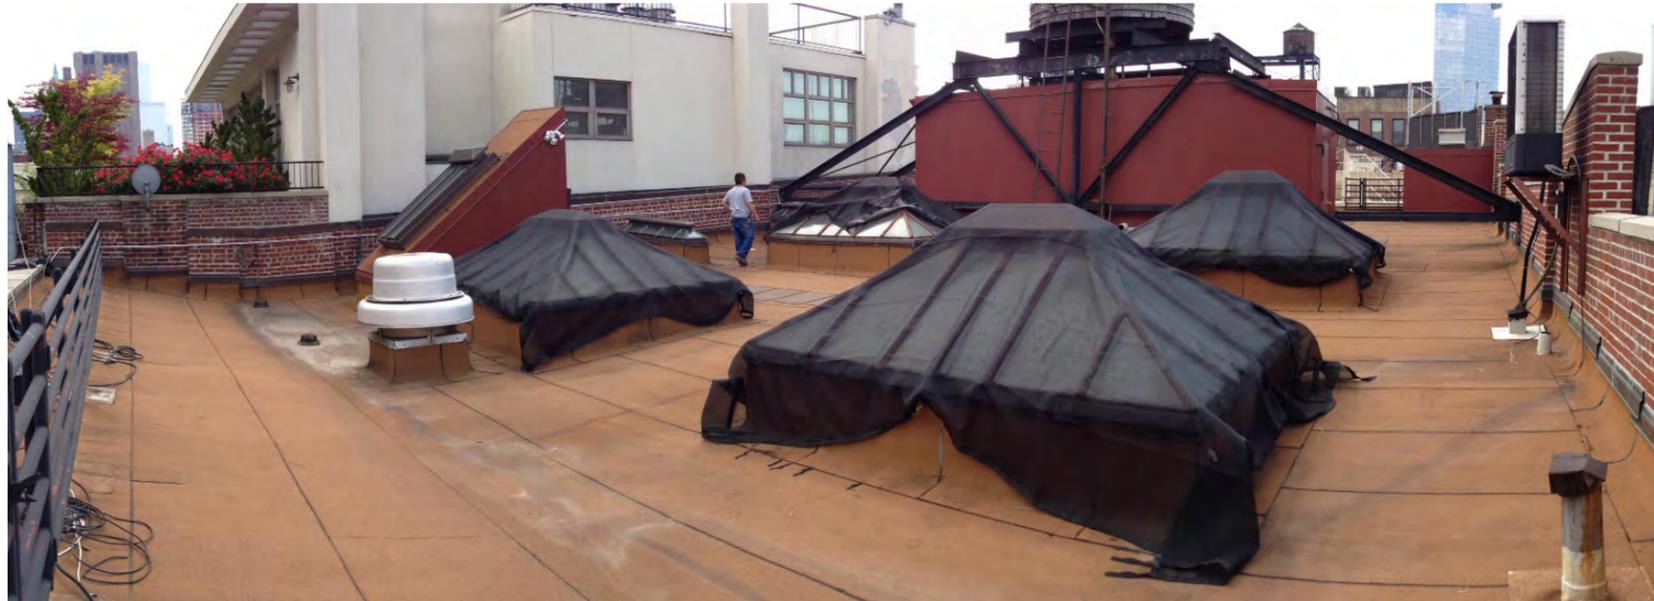
PHOTO 77: Roof level, general view. Skylights are covered with black netting.

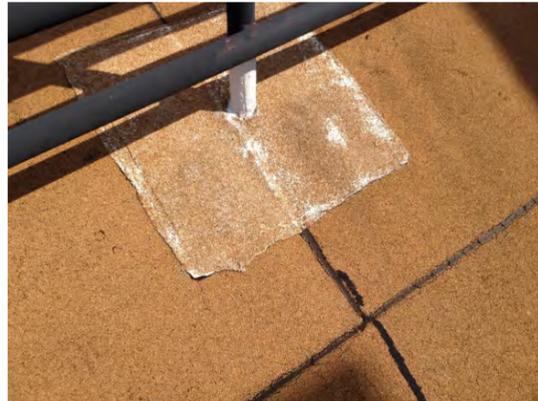
PHOTO 79: Typical condition of liquid applied flashing at railing penetration.

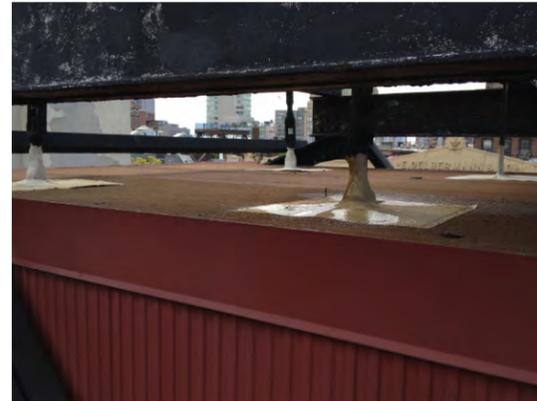
PHOTO 80: Bulkhead roof level. Typical condition of roof membrane and liquid applied flashing at dunnage penetrations.

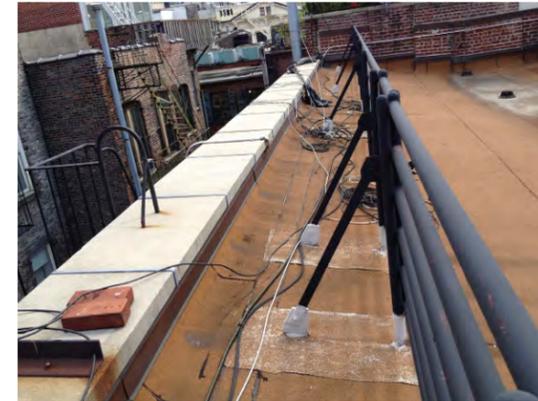
PHOTO 85: Components of roof level railing are in good condition.

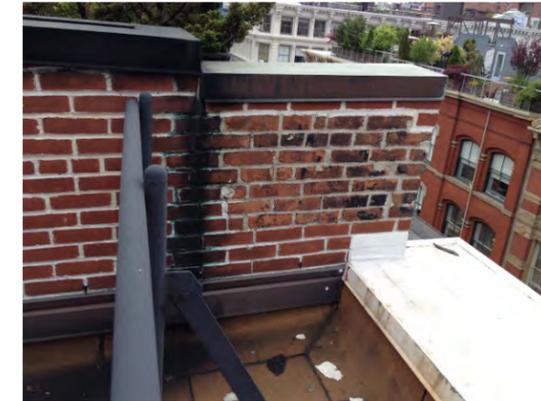
PHOTO 86: Roof level railings require repainting. Topcoat is chalky.

REPAIR ROOF METAL STRUCTURES AND RAILINGS, AND STAIR BULKHEAD.

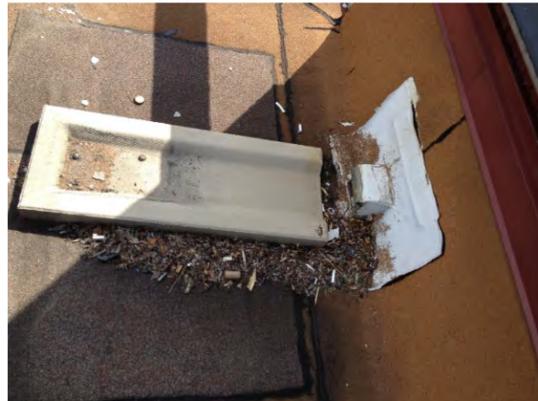
PHOTO 81: Liquid applied flashing at base (vertical application).

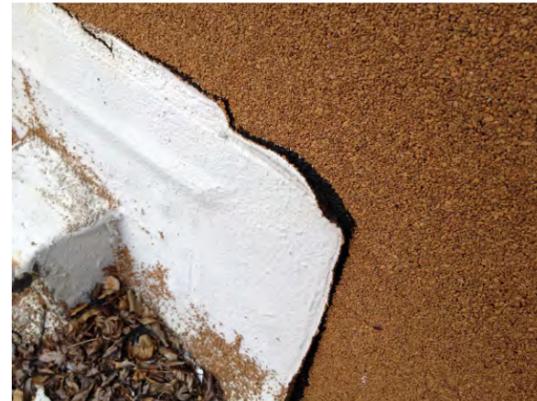
PHOTO 82: Close-up of liquid applied flashing at corner, which is detaching.

ROOF REPAIRS: FLASHING AND MEMBRANE OPENINGS TO BE SEALED.

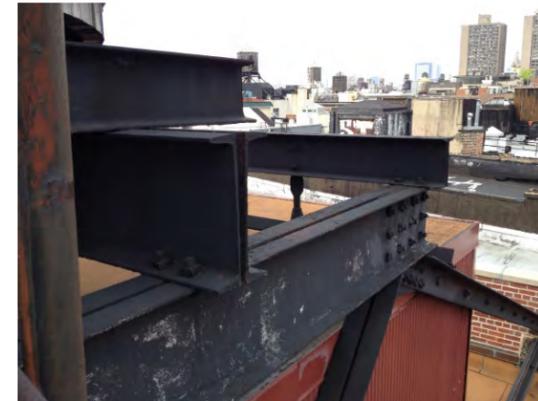
PHOTO 87: Dunnage is in good condition.

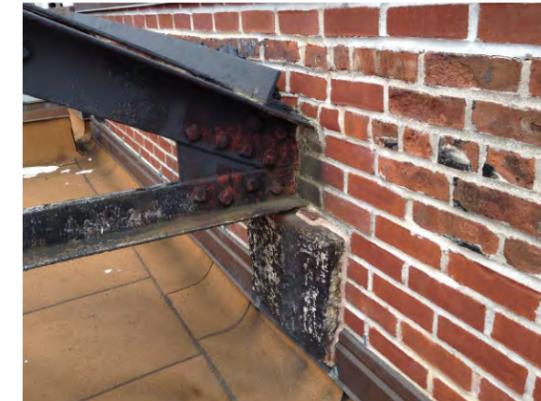
PHOTO 88: Dunnage requires repainting.

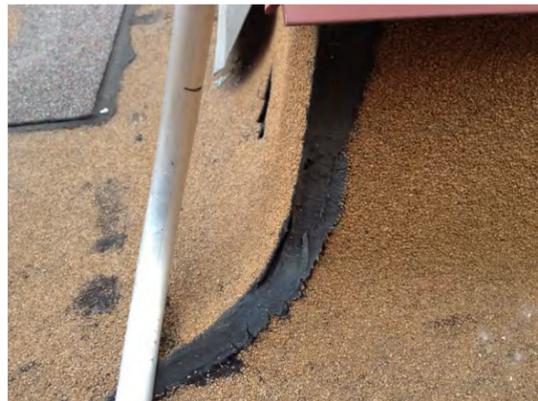
PHOTO 83: Roof membrane seams are open at a few locations and need to be serviced.

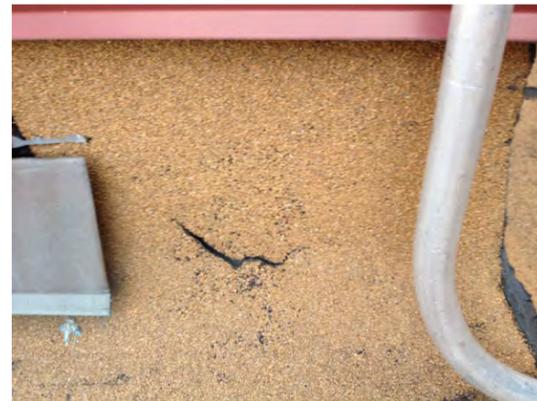
PHOTO 84: Roof base flashing is punched open next to the stair bulkhead door saddle.

ABBREVIATED SCOPE OF WORK:
- MAINTENANCE OF METAL WORK
- MAINTENANCE OF BASE FLASHING AT STAIR BULKHEAD
- INSPECT FLASHING AND SEAL OPEN SEAMS

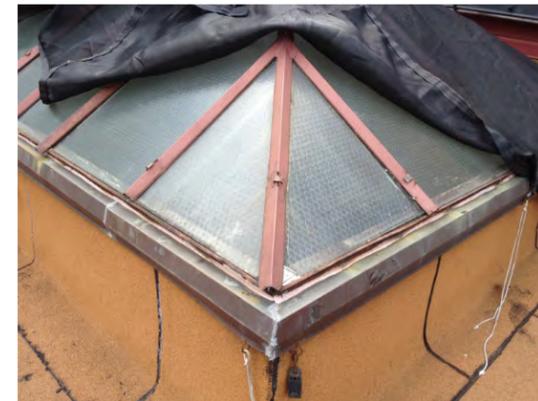
PHOTO 89: Refurbished skylight is in good condition.

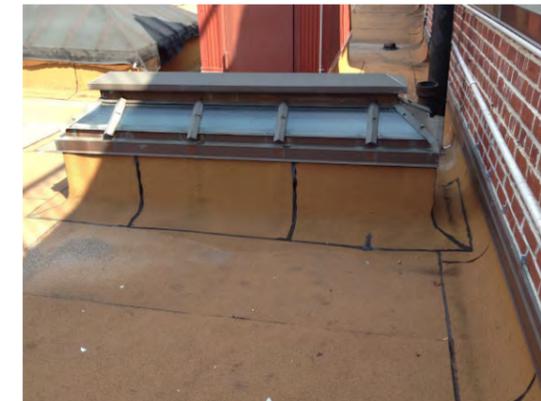
PHOTO 90: Replaced skylight is in good condition.

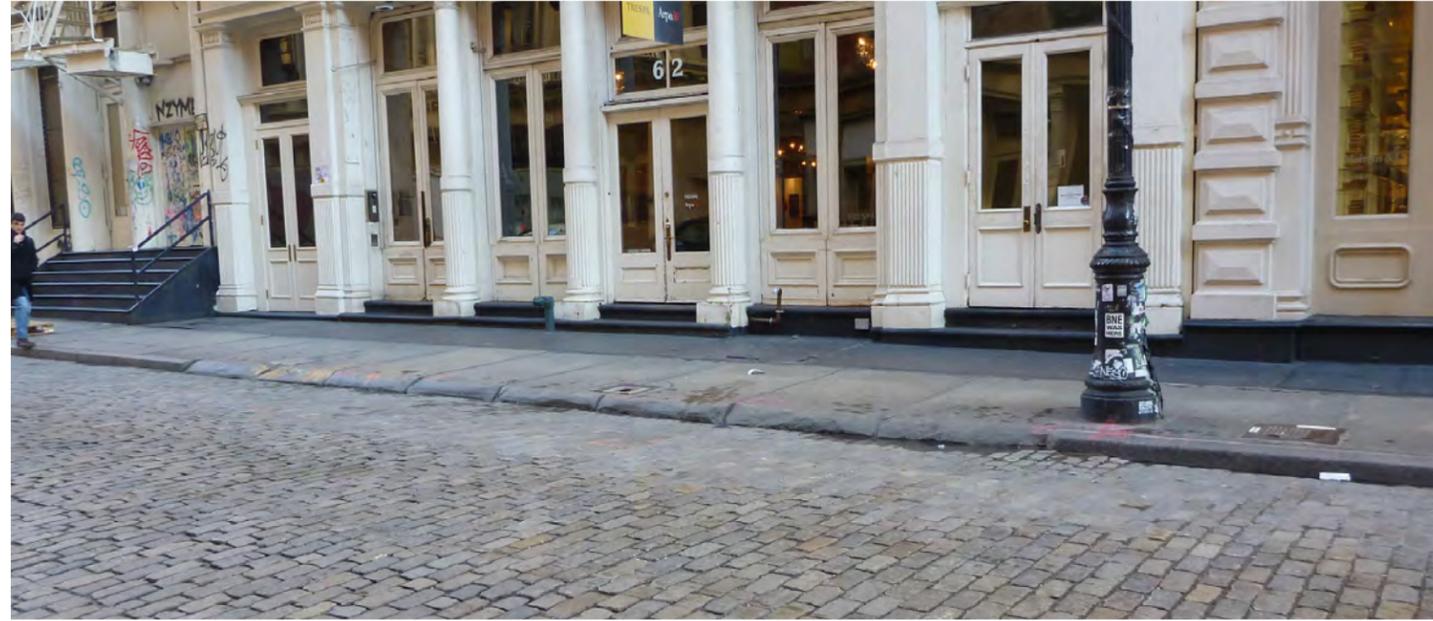
PHOTOS 90: General view of sidewalk conditions.

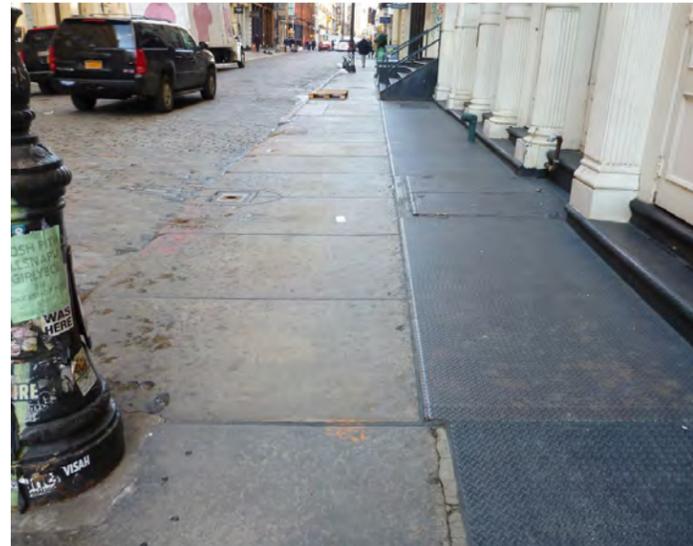
PHOTO 91: Sidewalk view from south.
