111 NOBLE RESIDENCES

111NOBLE STREET
BROOKLYN, NY 11222

LPC PRESENTATION
2016

Re: Structural Observation
111 Noble Street (Block 2566 – Lot 74 – BIN# 3064932)
Brooklyn, NY 11222

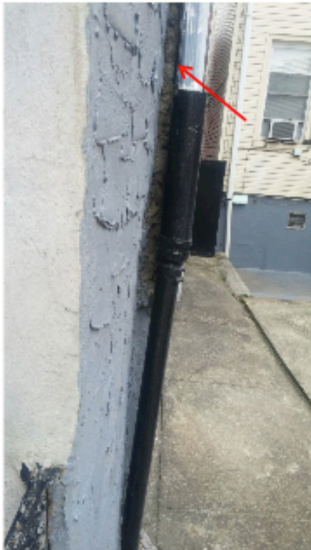
Photo 11: Exposed Corner Stud

The exterior of the building was observed. At the rear of the building, the north west corner of the building was observed to be bowing out significantly to the outside face, with the maximum deformation occurring at the 1st floor level. The north west corner wood stud was also observed to be exposed to the elements. See Photos 10 and 11 below. The 1st floor level adjacent to the west bearing wall was also observed from the inside, and was found to be to be significantly warped. See Photos 12 and 13 below. Due to the deformation of the floor and the wall, there is a concern that the connection of the floor framing to the west wall is compromised. The floor joists may slip off the west bearing wall and cause the building to collapse.

Based on these findings; due to the extent and nature of safety and stability issues encountered, as well as the observed signs of deformation and stress, we recommend that the building be rebuilt.

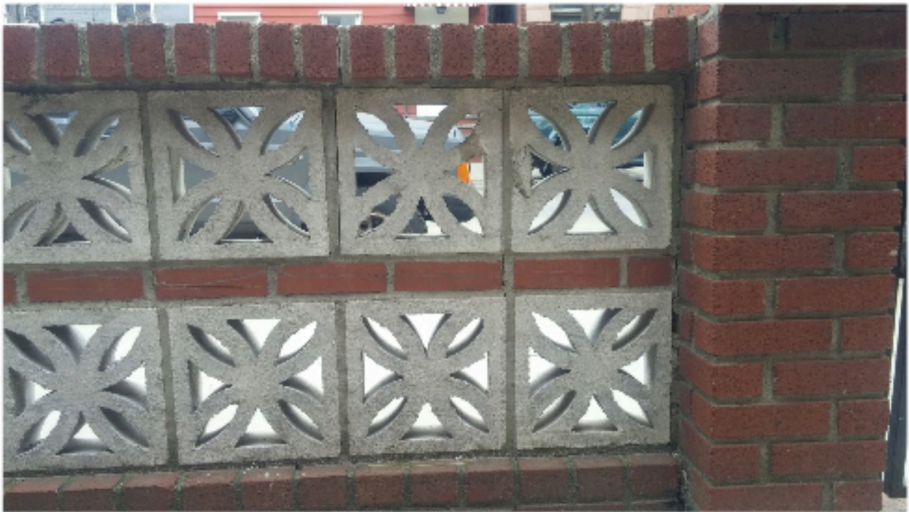
Photo 7: Front Divider

The brick piers and dividers in the front of the building were observed. The brick on the stairs and the dividers require repointing. See Photo 6 below. The brick divider between the front yard and the sidewalk is unstable and loose to the touch. See Photo 7 below. This divider needs to be repaired or replaced. In addition, a fine crack was observed on the porch barrier at the bearing end. See Photos 8 and 9 below. As a result, the construction of the header that supports this barrier and the stability of this porch barrier are questionable.

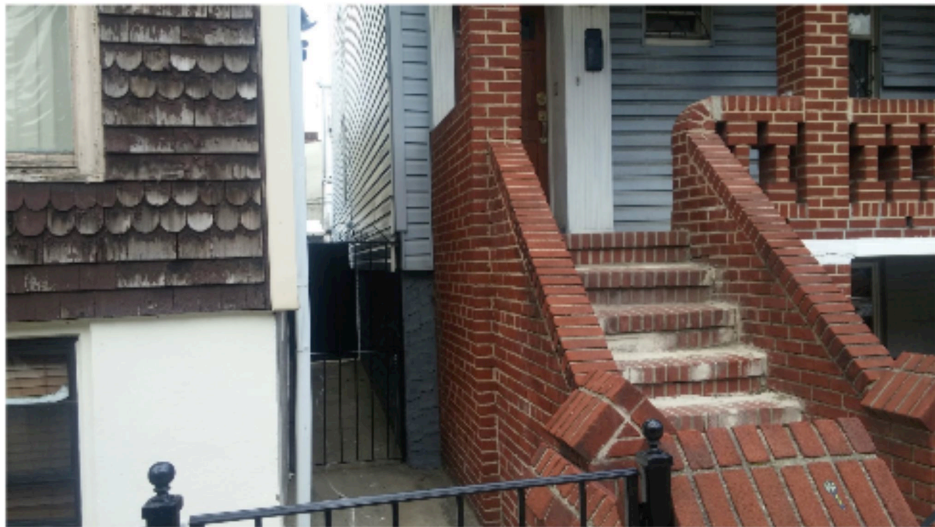
Photo 3: Front Porch and Brick Barriers

The façade of the building generally consists of vinyl siding that covers several layers of older siding. Some areas of siding was observed to be loose or damaged. See Photo 2 below. To the front of the building is a concrete porch at the 1st floor level covered by a metal canopy. The porch slab and canopy are supported by steel headers and brick piers. There is a concrete and brick stair leading to the porch. The porch and front yard are bounded by brick barriers. The porch and masonry at the front was not part of the original construction of the building. See Photo 3 below.

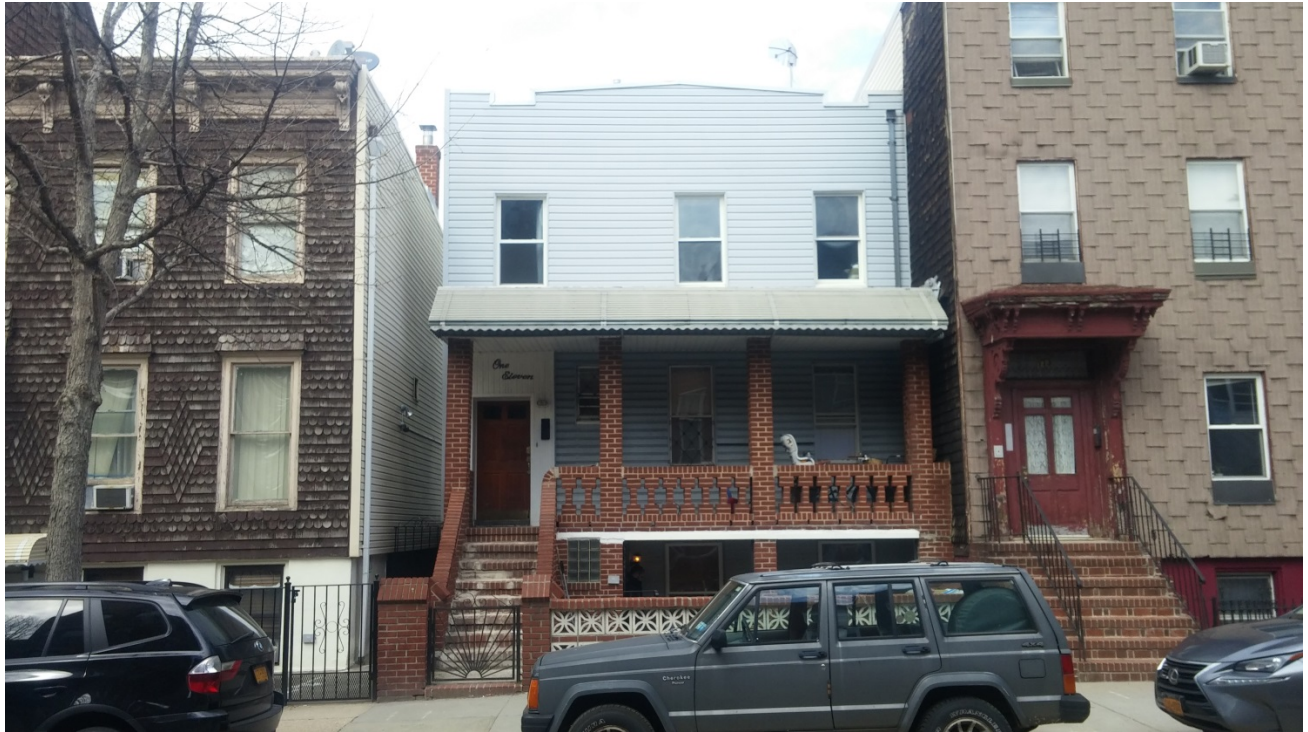
Photo 1: Street Elevation

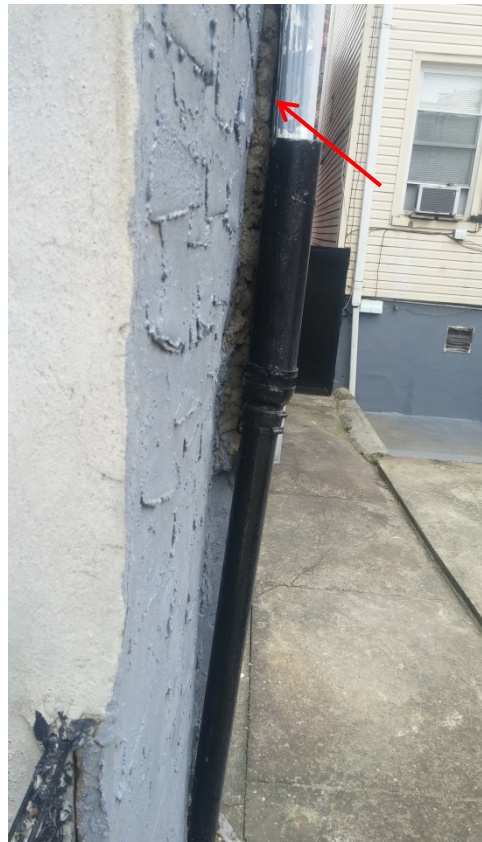
Photo 11: Exposed Corner Stud

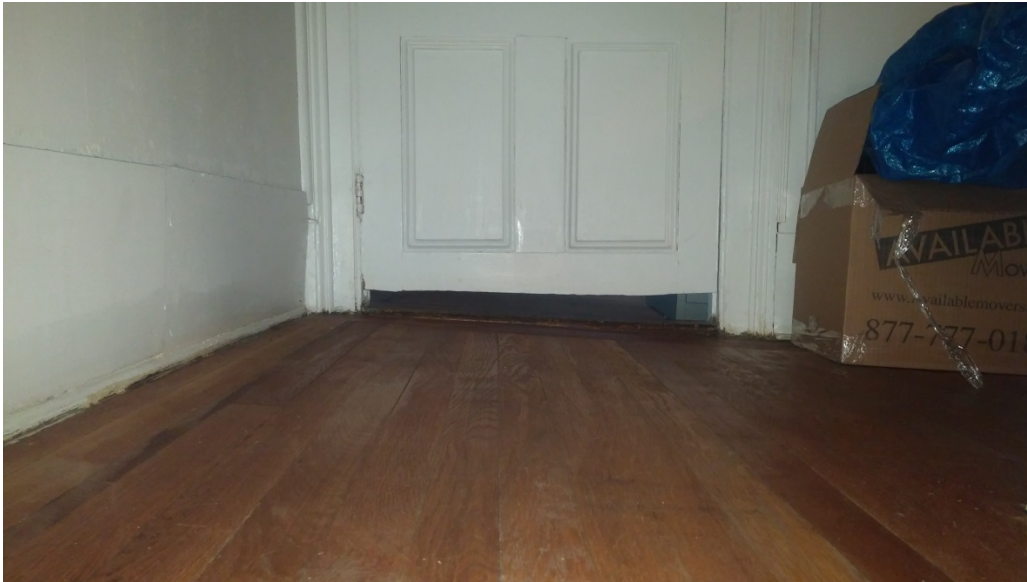
Photo 12: Sloped Floor at West Wall

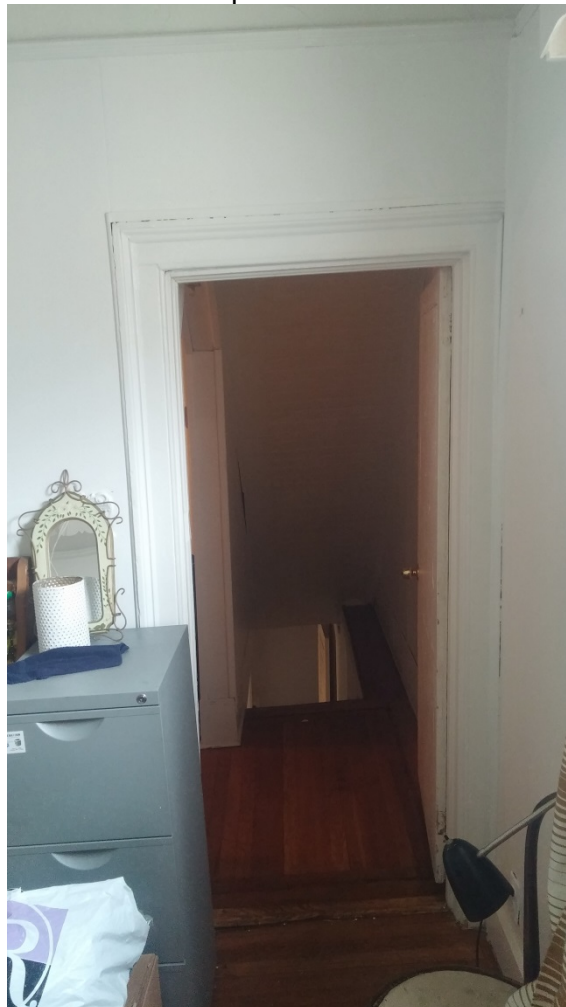
Photo 13: Warped Floor
